# PROPERTY INSPECTION REPORT

Inspector: Patrick Weevie

# SAMPLE

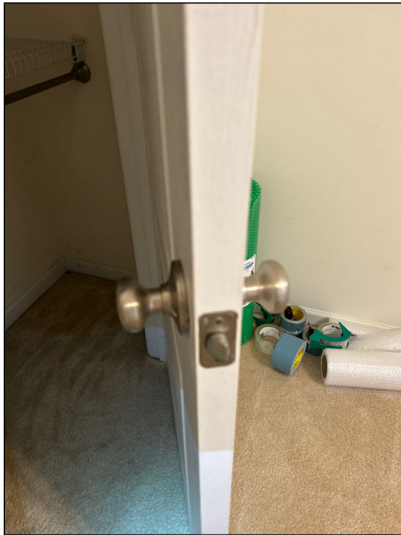
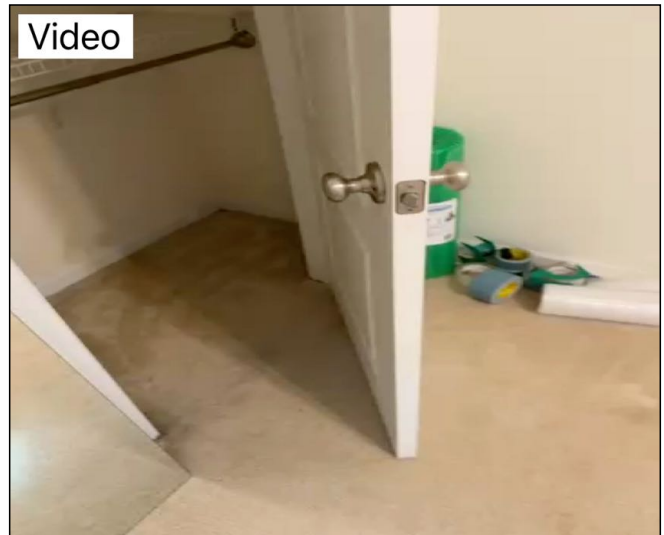
- Loose door handle in bedroom 3.
- Closet door or closes on its own in bedroom number 3.

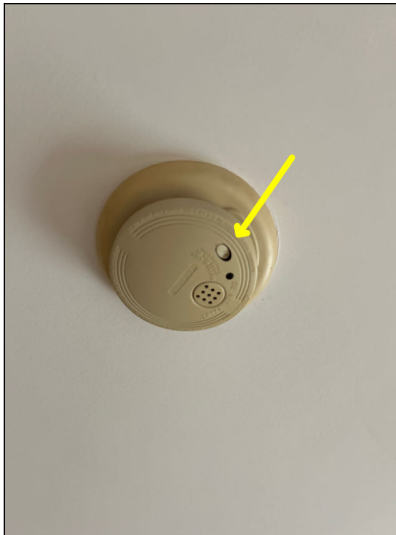
- The smoke detector in Bedroom 2 had a broken test button and could not be operated during the inspection. Because the device could not be tested, its functionality is unknown. Recommend replacing the smoke detector to ensure proper fire safety protection.

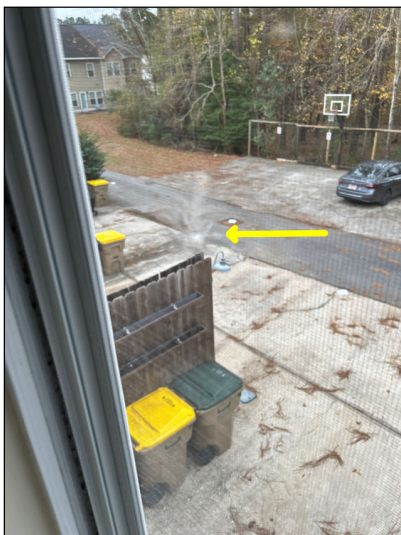
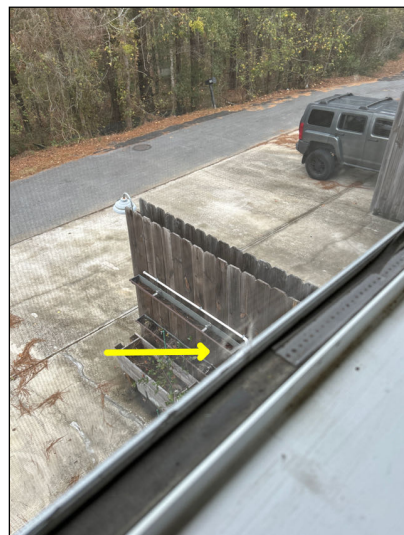
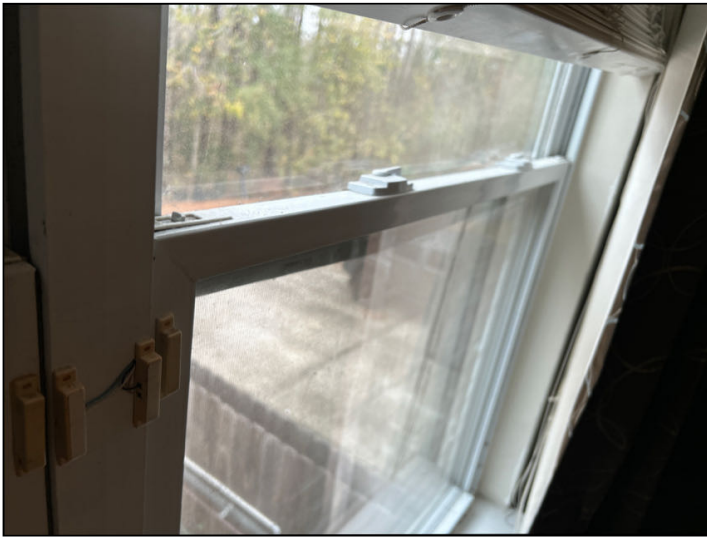
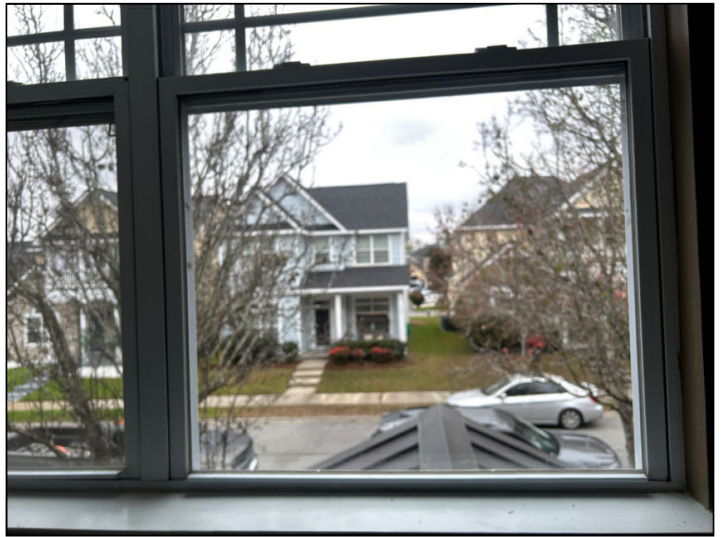
- Several window screens were torn or damaged. Damaged screens do not affect window operation but can allow insects to enter when windows are opened. Recommend repairing or replacing the affected screens as part of routine maintenance.
- A window screen was missing at Bedroom 1. Missing screens do not affect window operation but may reduce ventilation options and allow insects to enter when the window is open. Recommend replacing the screen.
- A single-hung window in the master bedroom was not secured at the window locks during inspection. When attempting to close and latch the window, it was noticeably difficult to operate. Improper window alignment, debris in the track, or worn hardware can prevent full closure and secure locking. Recommend evaluation and adjustment or repair by a qualified window or handyman professional to ensure proper operation and full locking capability.

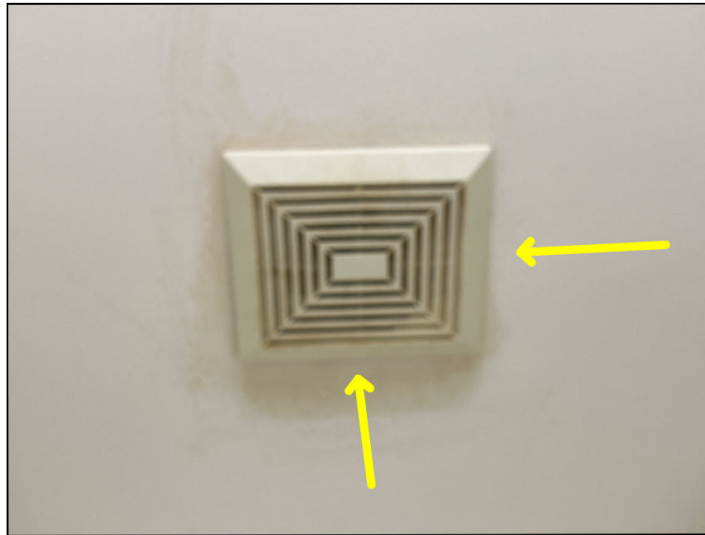
- The bathroom exhaust fan cover had noticeable dust and debris buildup. Accumulated debris can reduce airflow efficiency and increase noise during operation. Recommend removing the cover and cleaning the fan assembly as part of routine maintenance.

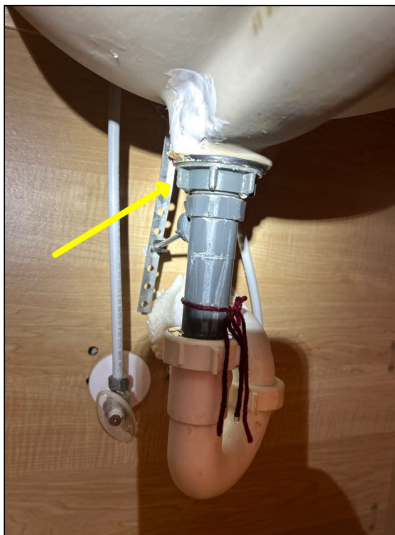
- A water function test was performed in the master bathroom. When multiple fixtures were operated simultaneously (tub and both sinks), a noticeable drop in water pressure and flow occurred. This may indicate restricted supply lines, mineral buildup, or an overall capacity limitation in the plumbing system. Recommend evaluation by a qualified plumber if pressure issues become a concern during regular household use.
- A leak was observed at the sink's drain connection where the tailpiece and P-trap join. Water was present on the piping during operation. Active leaks can damage cabinetry and contribute to microbial growth if not repaired. Recommend correction by a qualified plumber and evaluation for moisture-related damage.

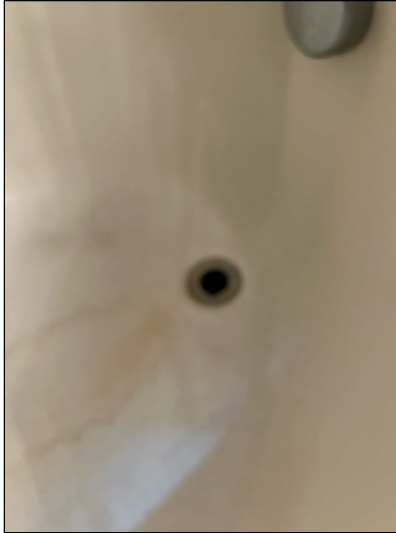
- The master bathroom tub is missing its drain stopper. Without a functioning stopper, the tub cannot be filled for soaking or certain testing procedures. Recommend installing an appropriate stopper assembly for proper operation.

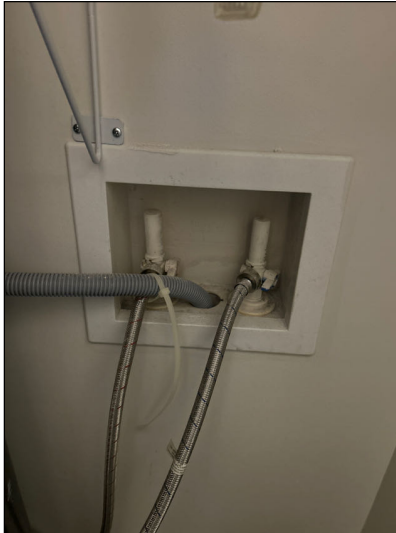
- The washing machine water supply valves had paint overspray on them at the time of inspection. This is noted for informational purposes only and is not considered a defect.

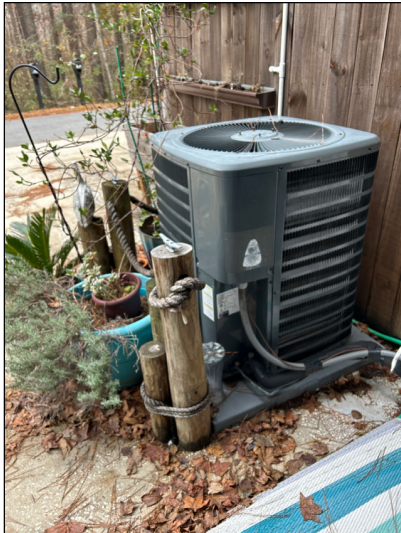
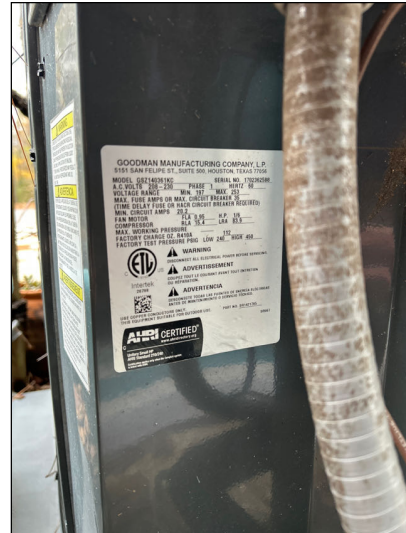
- The air conditioning system was not operated due to low outdoor temperatures (approximately 37.9°F at the time of inspection). Running the **A/C** when temperatures are below about 60°F can damage the system. This is an inspection limitation only. Recommend confirming proper cooling operation during seasonally appropriate temperatures.

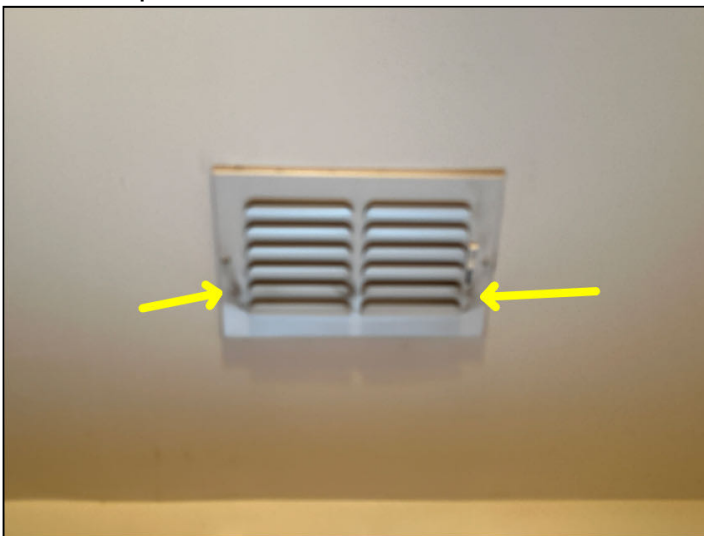
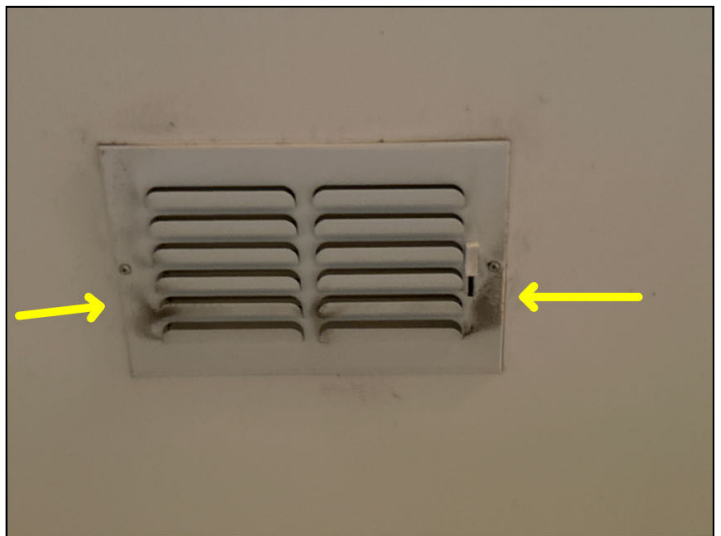
- Black discoloration was observed on several HVAC supply registers in the living room. This is often caused by dust accumulation combined with moisture, but microbial growth is also possible. The exact type cannot be determined during a visual home inspection. Recommend cleaning the registers and having the HVAC system, ductwork, and air filtration evaluated by a qualified HVAC technician to improve indoor air quality and prevent recurrence.

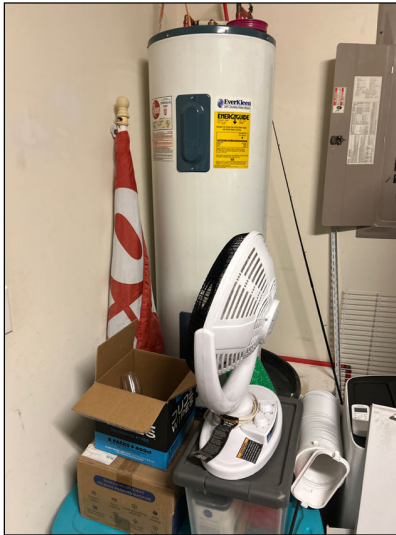
- Inspection of the water heater was limited due to personal items stored around and in front of the unit. Full access to the water heater and its components—including plumbing connections, drain pan, and safety devices—was restricted. Recommend ensuring the area is cleared if a more complete evaluation is desired.

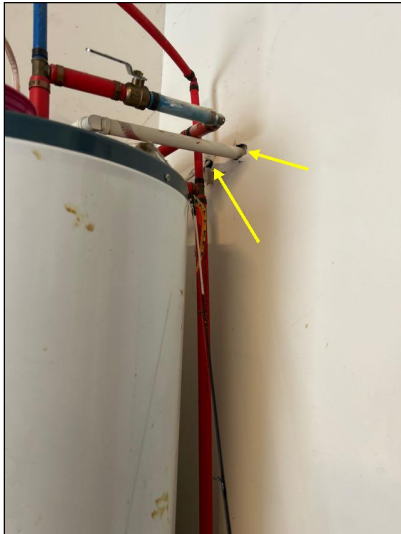
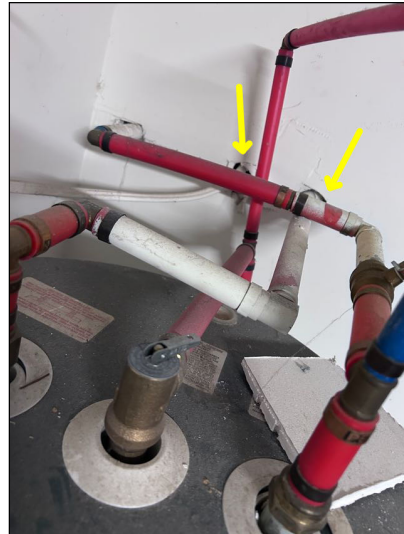
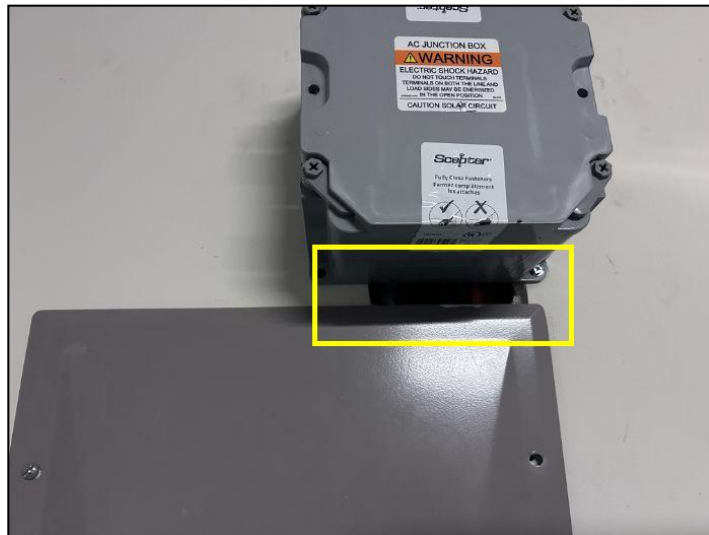
- Personal items prevent complete inspection.
- Gaps around plumbing and electrical penetrations into drywall recommend sealing gaps.

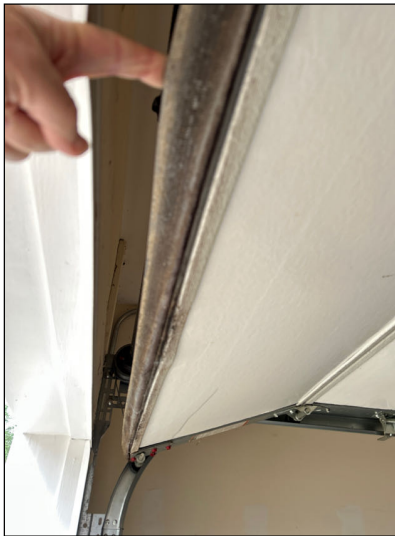
- The bottom weather seal (rubber boot) on the overhead garage door is cracked and split along most of its length. This reduces the door's ability to seal properly and may allow drafts, moisture, and pests to enter the garage. Recommend replacement of the bottom seal to restore proper weather-resistance.

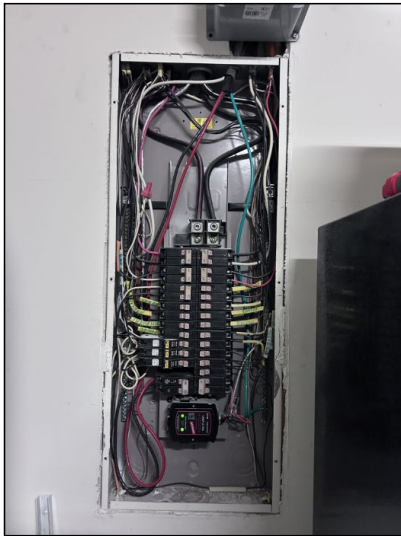
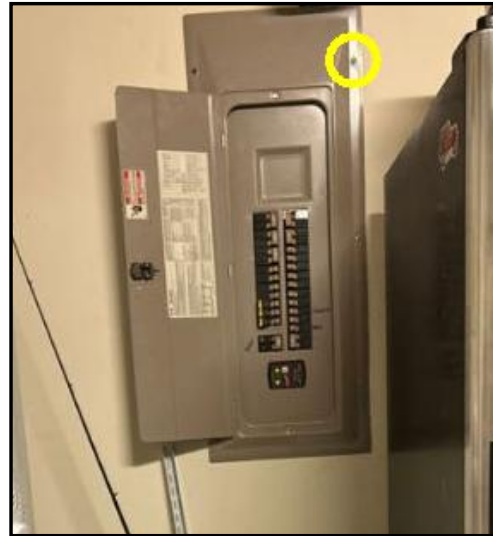
- No major system safety or function concerns noted at time of inspection at sub panel box.
- Could not determine the size of the sub-panel due to missing data plate.
- A sub-panel was present in the garage.
- Panel cover screw(s) missing.

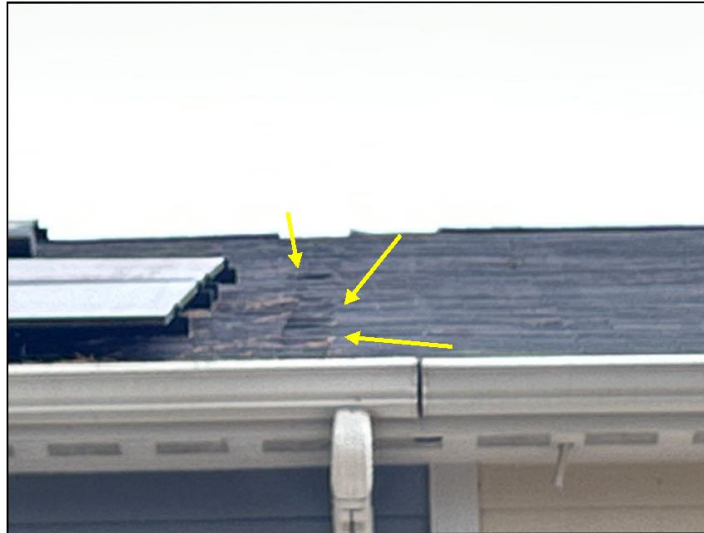
- The roof could not be walked during the inspection due to accessibility and/or safety limitations. As a result, a full evaluation of the roof covering and related components was not possible. Recommend further assessment by a qualified roofing contractor to fully evaluate the roof's condition and identify any deficiencies that may not have been visible from the ground or other vantage points.
- Some shingles appear to be slightly curling.

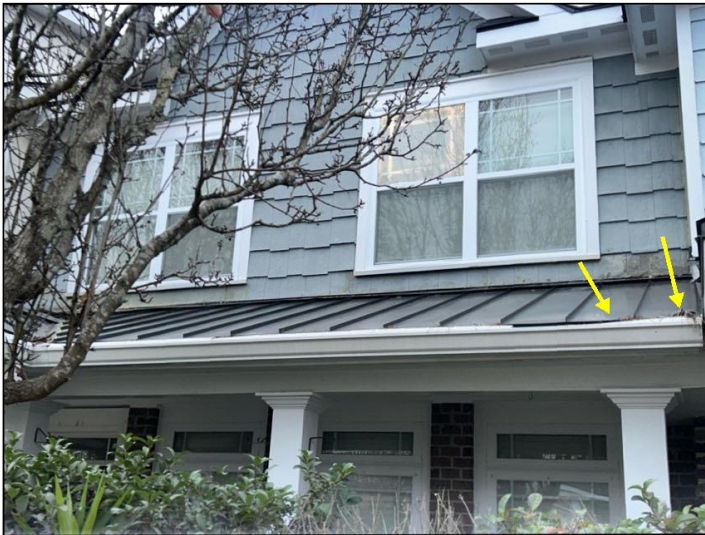
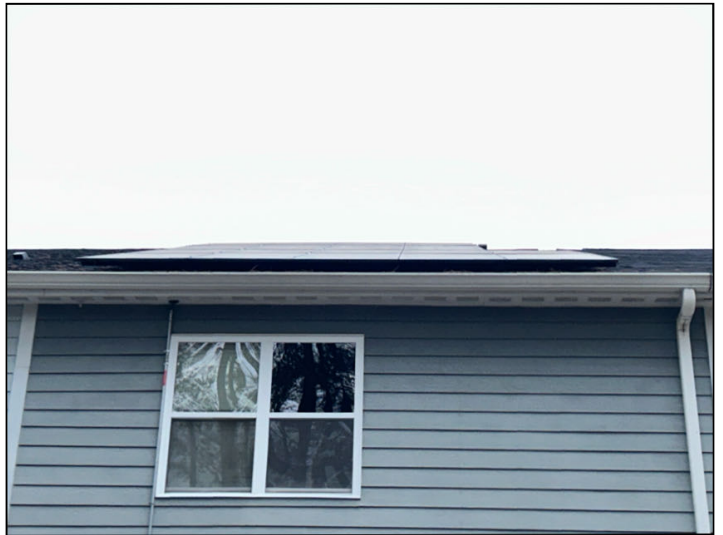
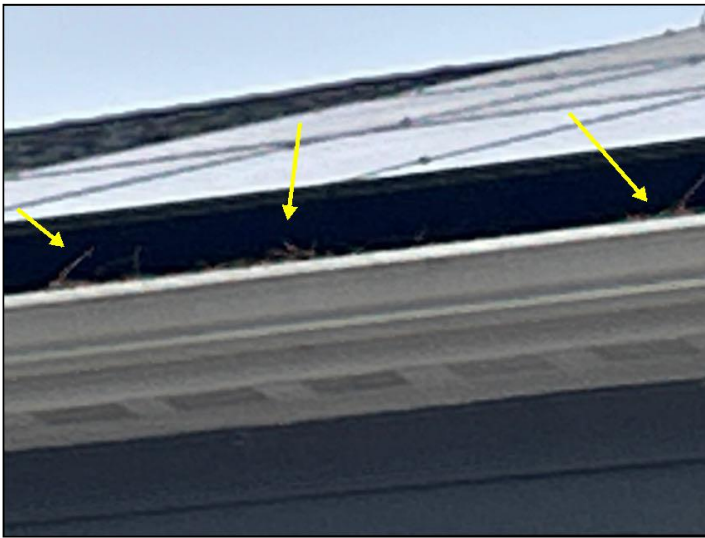
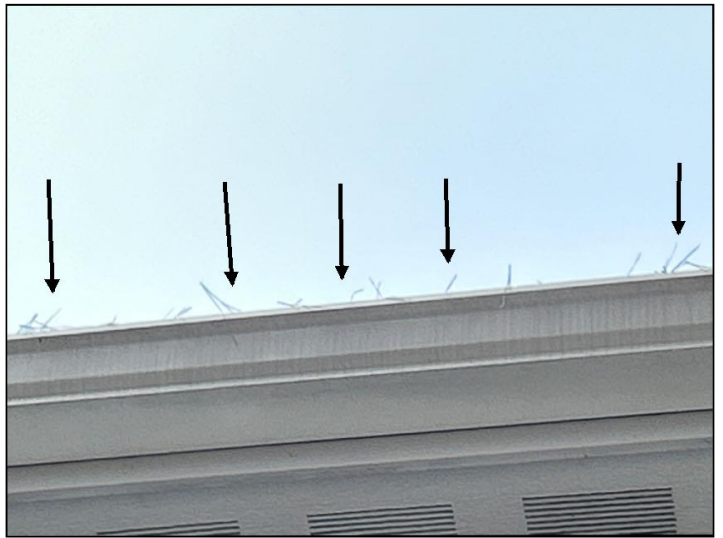
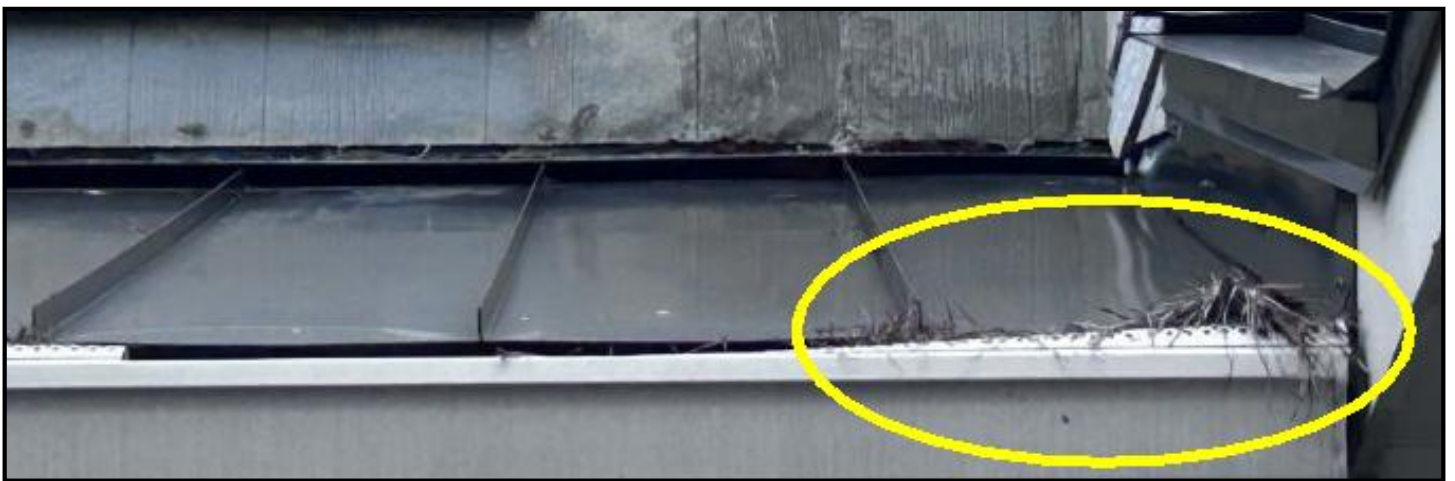
- From ground level, I observed visible debris accumulation in sections of the gutters—particularly at the front and rear of the home. Because the roof was not walked, my view of the gutter interior was limited, and additional debris or blockages may be present. Debris-filled gutters can impede proper drainage and contribute to moisture-related issues at roof edges. Recommend having the gutters cleaned.

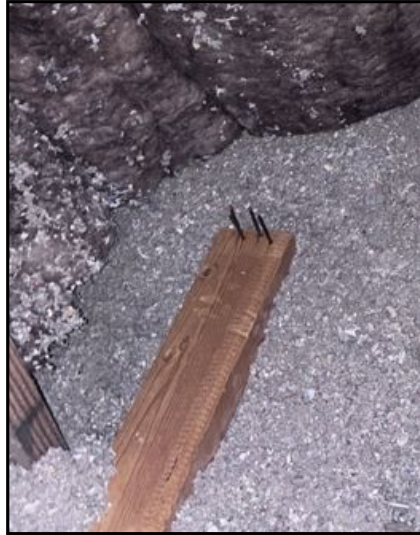
- A loose board with multiple exposed nails was observed laying on the attic floor. This presents a safety hazard for anyone entering the attic, including the homeowner or service personnel. Recommend removal of the board or securing it in a safe location to prevent injury.

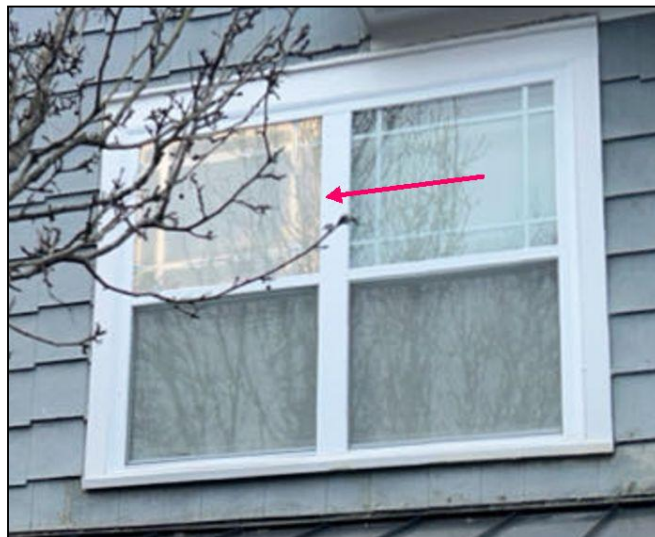
- The upper window in the second-floor bedroom exhibited visible discoloration or hazing between the glass panes. This condition is consistent with a possible failed thermal seal, which allows moisture to enter the insulated glass unit. When window seals are compromised, the window may become cloudy over time and lose some insulating efficiency. Recommend evaluation and repair or replacement by a qualified window contractor.

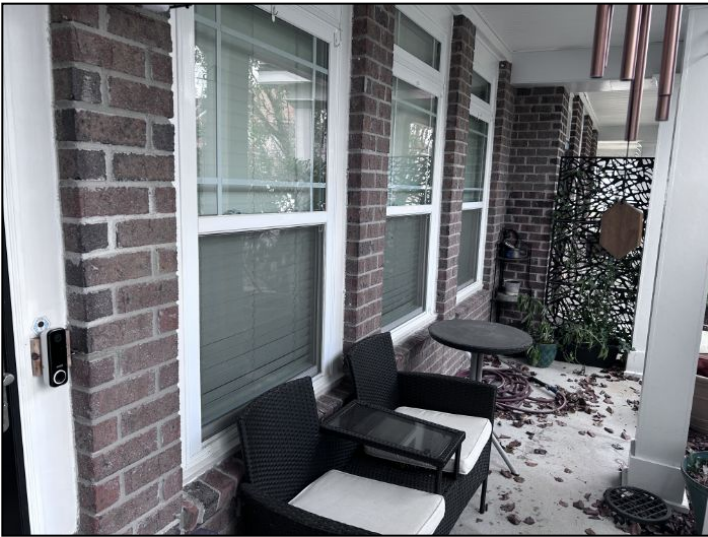
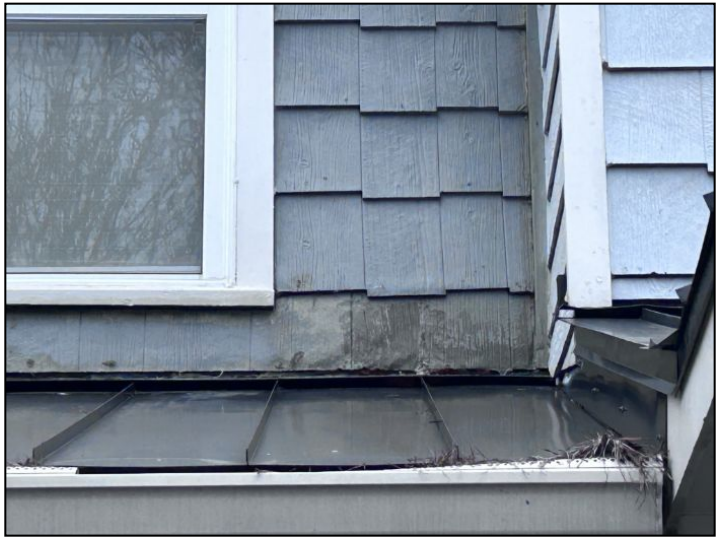
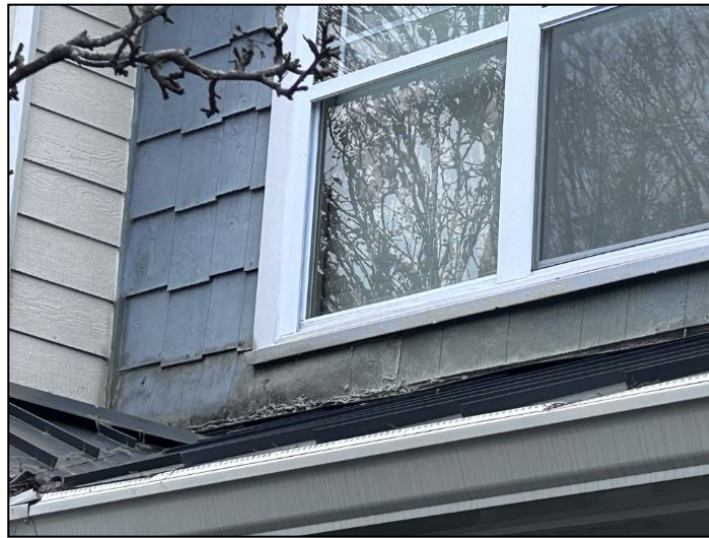
- From ground level and at a limited vantage point, the exterior siding and roof-to-wall flashing area beneath the upper window show signs of discoloration, deterioration, and possible moisture staining. The flashing configuration could not be fully evaluated from this distance, but the conditions observed may indicate improper or aging flashing and potential water intrusion. Recommend a closer evaluation by a qualified roofing or siding contractor and repairs as needed.

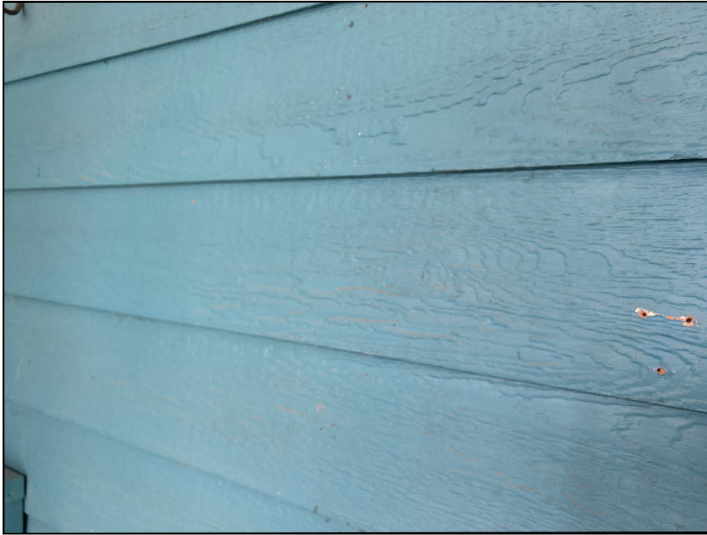
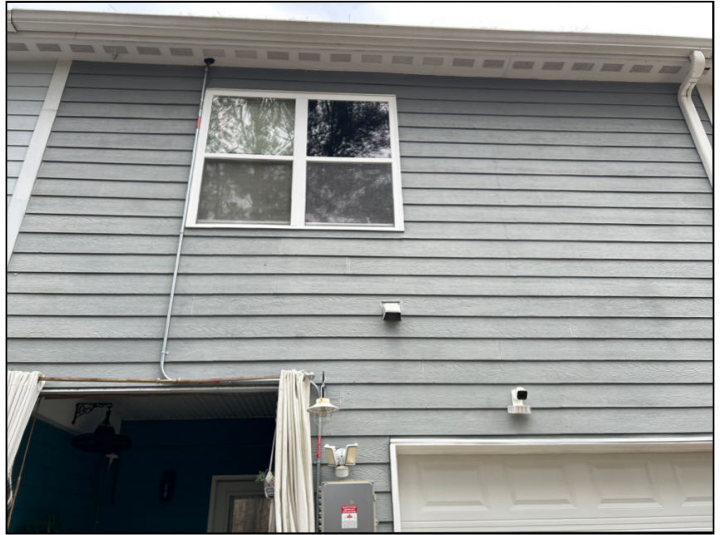
- Several nail holes were observed in the composition wood siding. These openings can allow moisture to enter the siding, which may lead to deterioration or swelling over time. Additional unobserved holes may also be present. Recommend sealing all penetrations and repainting the affected areas to maintain the siding's protective surface.
- Paint on the exterior siding appears weathered and faded in areas. While cosmetic, fading can indicate the need for future repainting to maintain proper protection against moisture and UV exposure. Recommend planning for routine repainting as part of normal home maintenance.

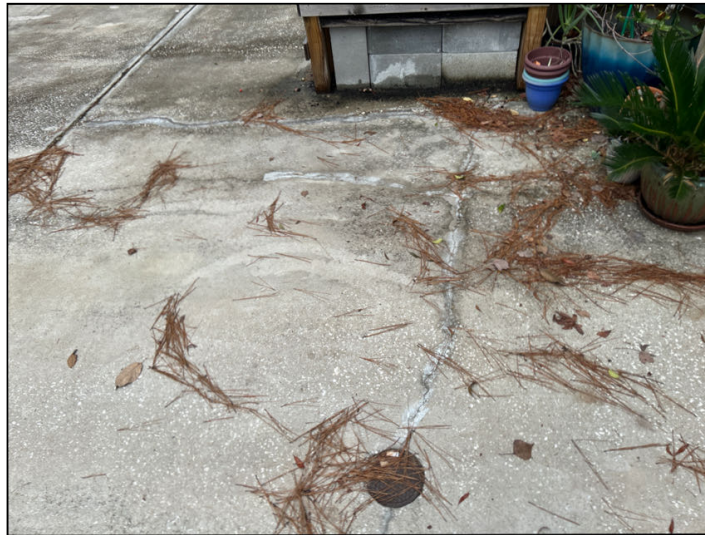
- Cracking was noted in the concrete driveway. These appear to be typical settlement or shrinkage cracks common in exterior concrete surfaces. Recommend sealing the cracks to help prevent further deterioration and moisture infiltration. No significant displacement was observed at the time of inspection.

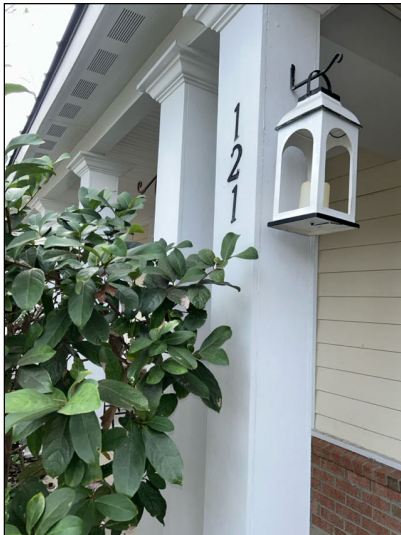
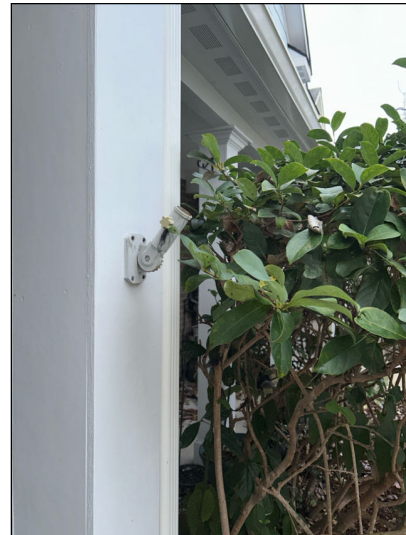
- Vegetation is in direct contact with the exterior columns and structure. Plants touching the home can trap moisture, promote wood deterioration, and provide pathways for pests. Recommend trimming vegetation away from the structure to maintain proper clearance and reduce the risk of damage.

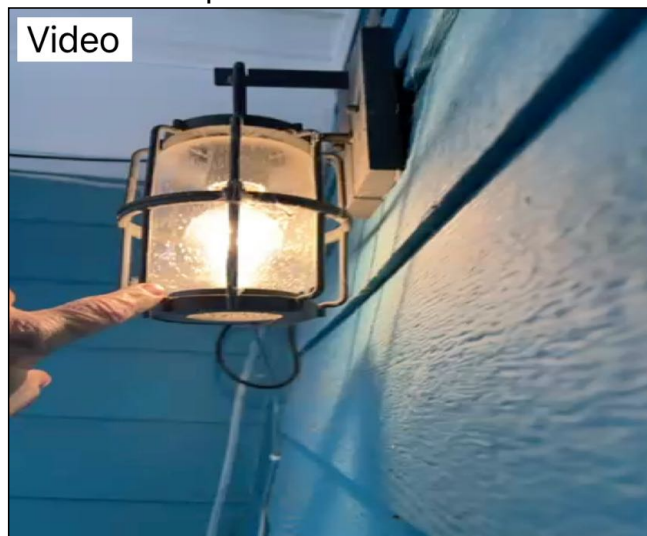
- No major system safety or function concerns noted at time of inspection.
- An exterior light fixture was loose and rocked when touched. Loose fixtures can stress the wiring connections and may eventually detach from the wall. Recommend securing the fixture properly to ensure safe operation.

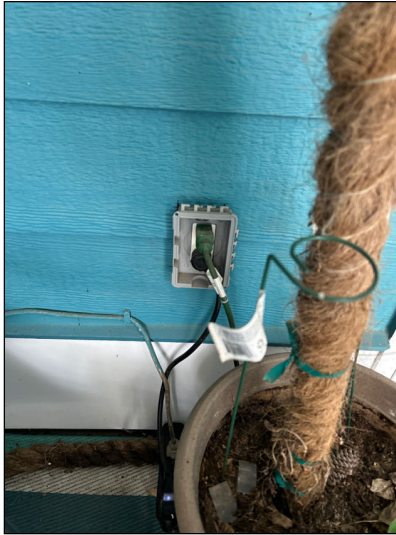
- The exterior electrical receptacle is missing its required weatherproof "in-use" cover. Without a proper cover, the outlet and connected devices are exposed to moisture, creating a potential shock hazard and risk of equipment damage. Recommend installing a code-approved weatherproof cover suitable for use while cords are plugged in.

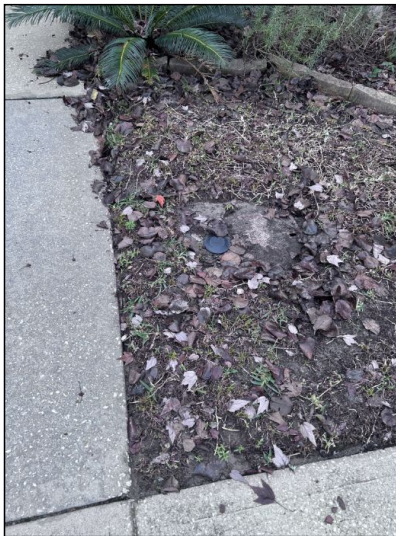
- The water meter vault in front of the home was partially covered with leaves and soil. Access to the meter should remain unobstructed for utility personnel and emergency shutoff. Recommend clearing debris from around the vault as part of routine yard maintenance.

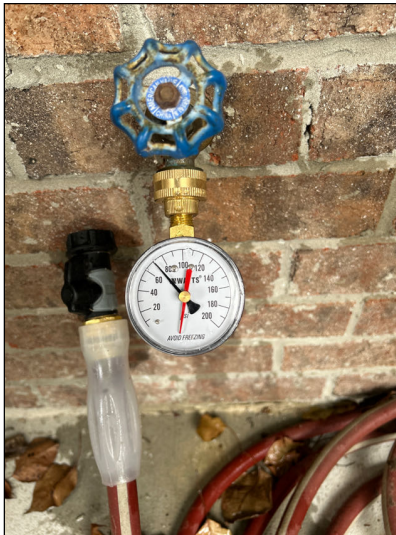
- Exterior water pressure tested at approximately 70 PSI. While this is below the maximum recommended limit of 80 PSI, it is on the higher side and may contribute to plumbing wear over time. Recommend monitoring the pressure and ensuring the home has a properly functioning pressure-reducing valve (PRV) if needed.

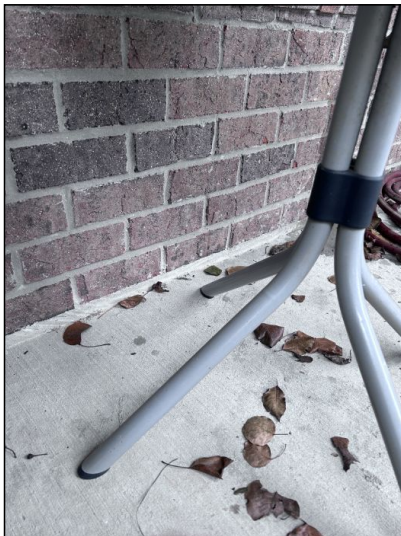
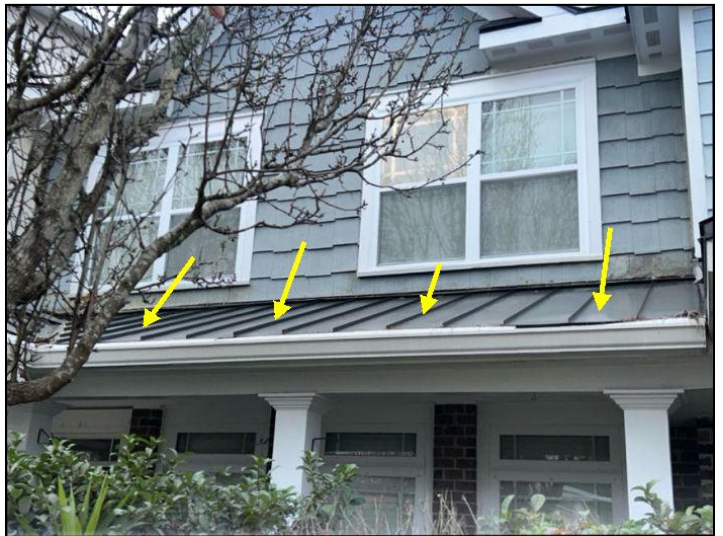
- The brick veneer at the front porch did not appear to have visible weep holes. In many exterior veneer installations, weep holes are installed at the base of the wall to allow drainage and ventilation of the cavity behind the brick. Because the construction details behind the veneer are not visible during a home inspection, it is unclear whether a drainage cavity is present in this location. Recommend further evaluation by a qualified masonry contractor to confirm proper installation and moisture management for this section of the wall.
