# PROPERTY INSPECTION REPORT

Inspector: Patrick Weevie

# SAMPLE

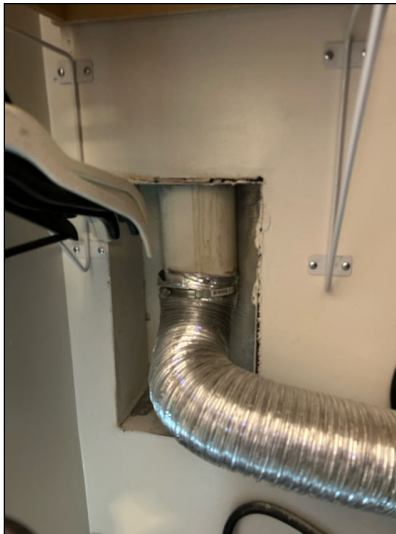
- A photo of the dryer vent connection is provided for reference only. No deficiencies were noted at the time of inspection. The inspector does not move appliances, and dryer vent routing beyond visible areas is not fully evaluated as part of a general home inspection.

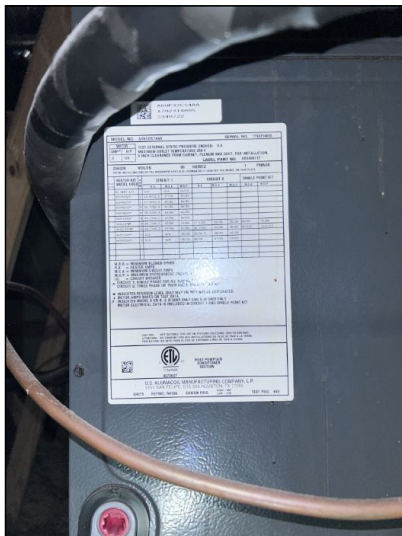
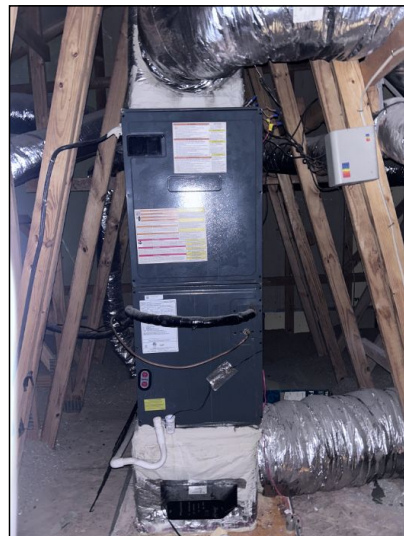
- Data plate information was photographed for reference.

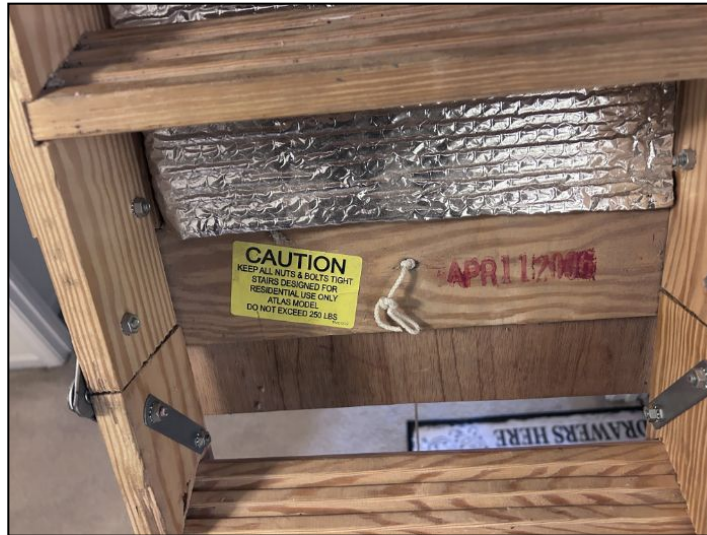
- The attic access ladder is stamped with a manufacture date of April 11, 2006. The ladder operated normally at the time of inspection. This date is provided for reference only.
